Office of Structural Materials

Quality Assurance and Source Inspection

Contract #: 04-0120F4Cty: SF/ALA Rte: 80 PM: 13.2/13.9File #: 69.28**WELDING INSPECTION REPORT****Resident Engineer:**Siegenthaler, Peter**Address:** 333 Burma Road**City:** Oakland, CA 94607**Report No:** WIR-018344**Date Inspected:** 23-Nov-2010**Project Name:** SAS Superstructure**OSM Arrival Time:** 700**Prime Contractor:** American Bridge/Fluor Enterprises, a JV**OSM Departure Time:** 1900**Contractor:** Zhenhua Port Machinery Company, Ltd (ZPMC), Changxing Island **Location:** Shanghai, China**CWI Name:** Mr. Yu Dong Ping**CWI Present:** Yes No**Inspected CWI report:** Yes No N/A**Rod Oven in Use:** Yes No N/A**Electrode to specification:** Yes No N/A**Weld Procedures Followed:** Yes No N/A**Qualified Welders:** Yes No N/A**Verified Joint Fit-up:** Yes No N/A**Approved Drawings:** Yes No N/A**Approved WPS:** Yes No N/A**Delayed / Cancelled:** Yes No N/A**Bridge No:** 34-0006**Component:** Tower / OBG**Summary of Items Observed:**

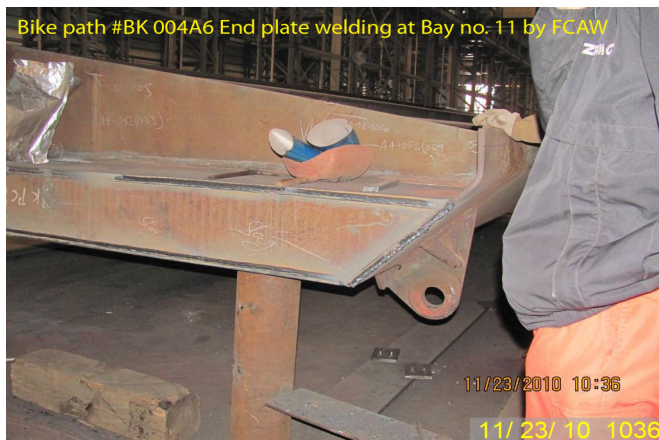
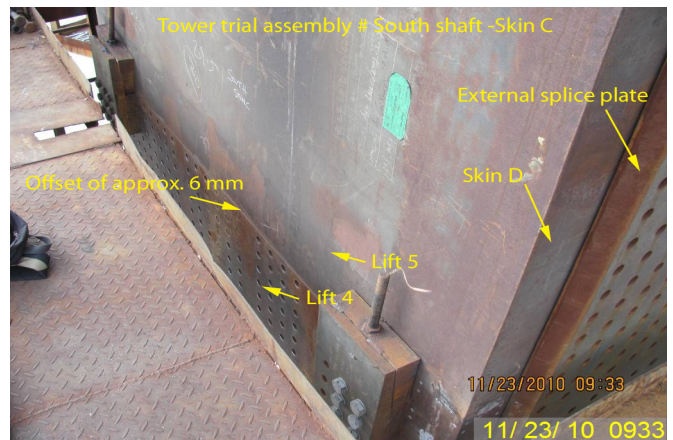
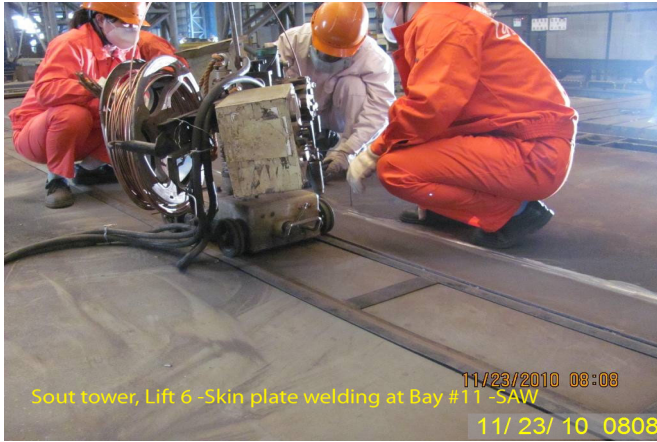
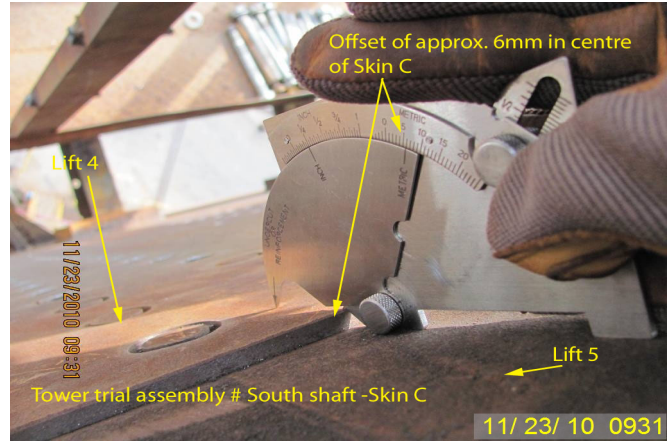
This QA Inspector observed an offset of approximately 6 mm between Lift 4 and 5 of South tower, Skin C. This has been photographed and reported to Task leader and SMR. Some photographs is attached with this report.
